# CONSERVATION OF GHANTA GHAR, JABALPUR

**TENDER DRAWINGS**

**PREPARED FOR  
JABALPUR SMART CITY LTD.**

heritage consultants pvt. ltd.

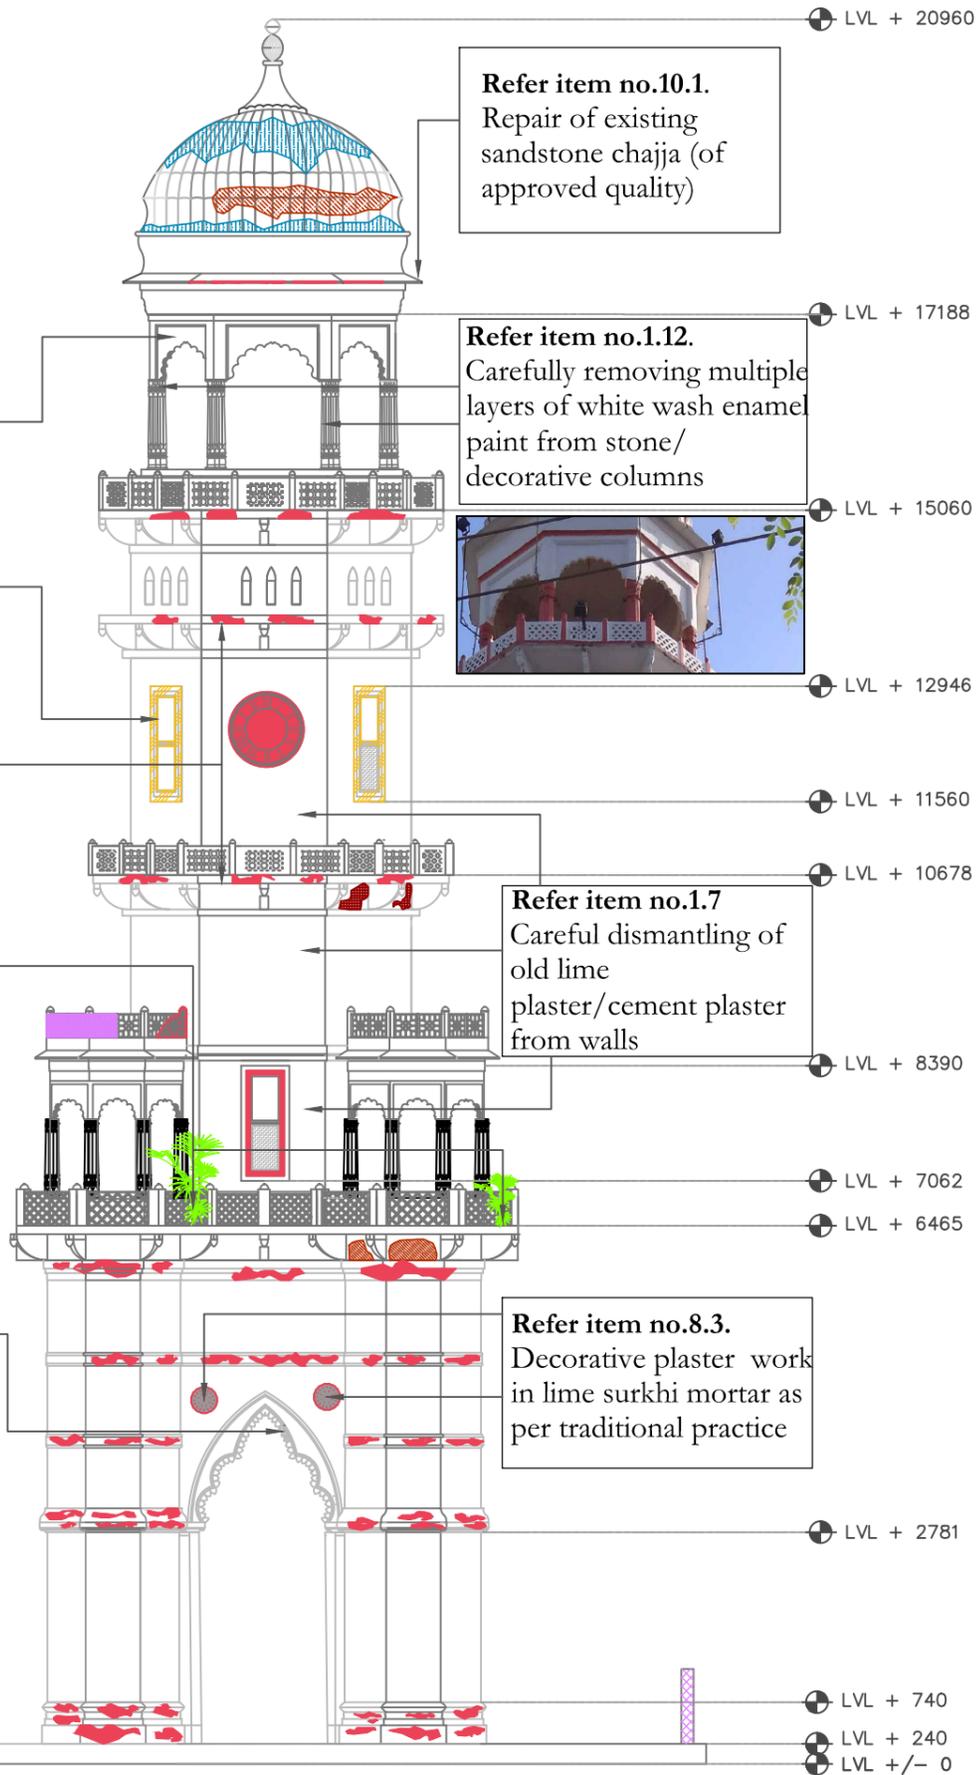
FRONT ELEVATION

**Refer item no 4.6**  
Consolidation of Lime plaster with grouting.

**Refer item no.6.2**  
Providing and fixing new doors, windows and ventilators .

**Refer item no.10.4**  
Repair of existing sandstone chajja

**Refer item no.1.10**  
De-vegetation from the monuments by chemical injection

**Refer item no.10.9.**  
Poviding and fixing new carved stone in place of damage stone member from panpatta base to Arch level

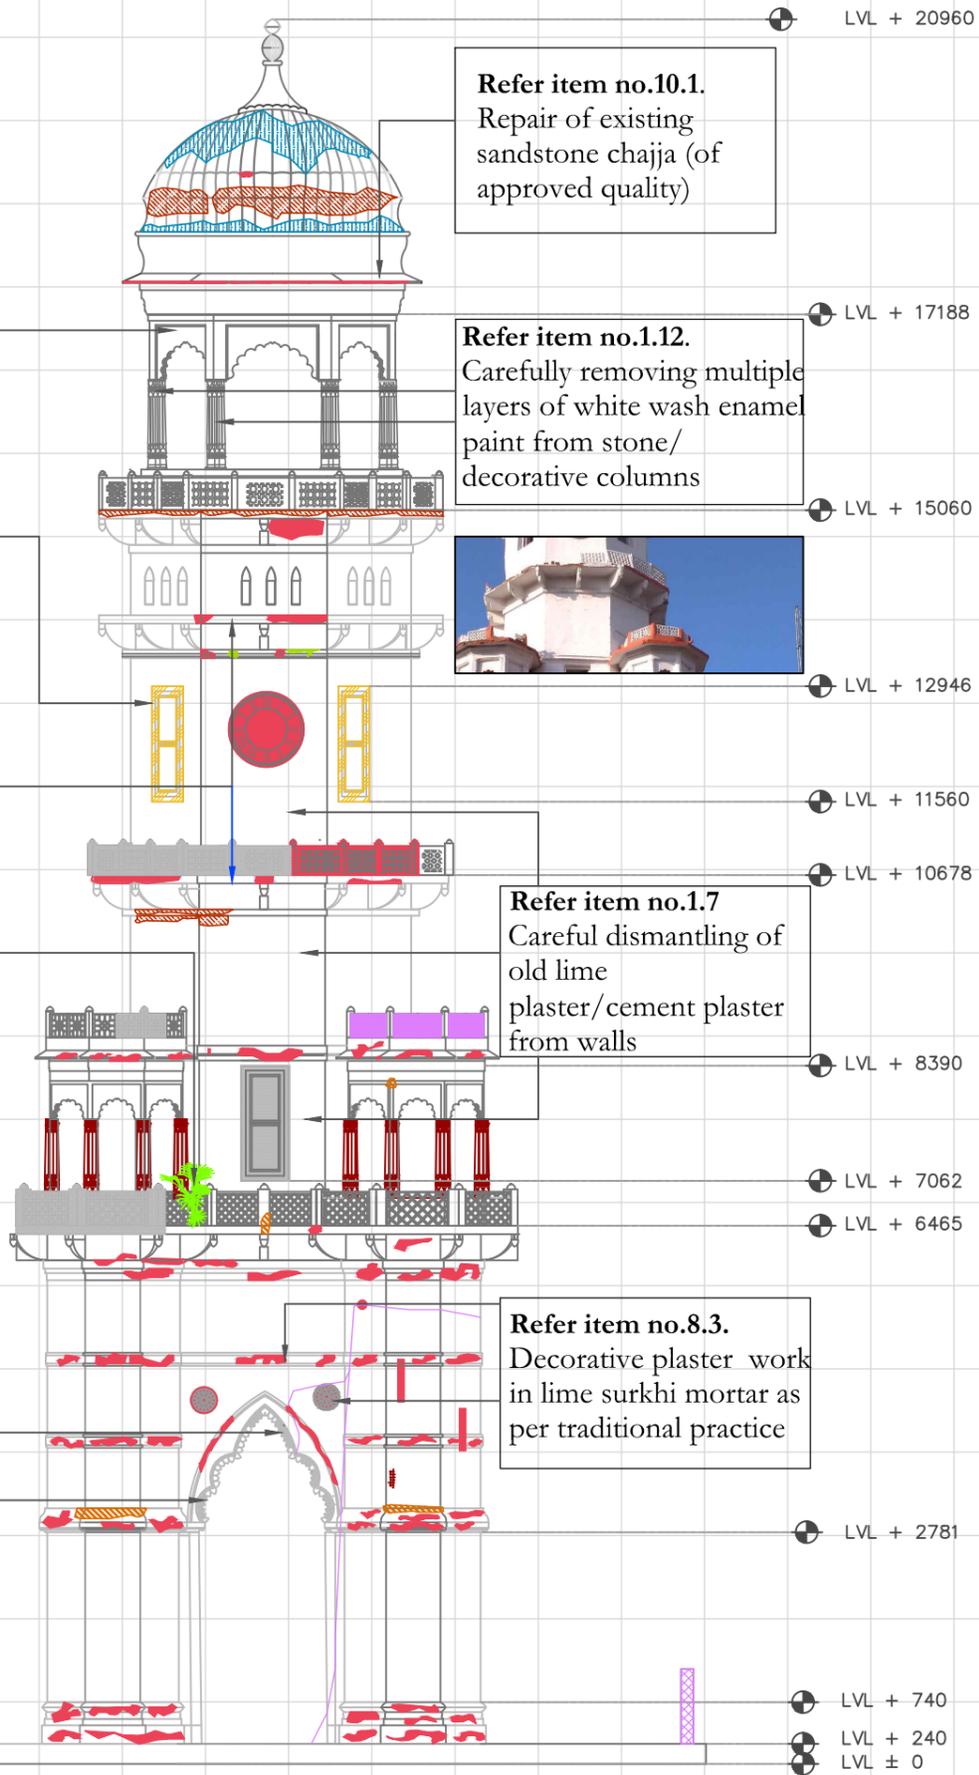
REAR ELEVATION

**Refer item no.1.12.**  
Carefully removing multiple layers of white wash enamel paint from stone/ decorative columns/ vertical surfaces/ Jaali, gently

**Refer item no.10.6.**  
Restoration of traditional Watch exist in the building tower

**Refer item no.10.3.**  
Repair of existing hanging decorative stone brackets with complete length of support stone
